Sample Building Inspection Report

Property Address: xxxxxxxx

Inspection Date: 10 January 2024

Prepared By: F Home Inspection

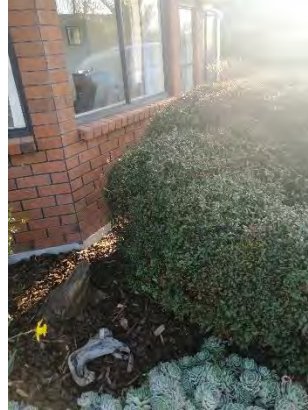
7.2 SITE EXPOSURE, CONTOUR AND VEGETATION

The house was positioned on a near flat section. **It is recommended that any vegetation touching the cladding is removed to help prevent the chance of moisture ingress in the future.**

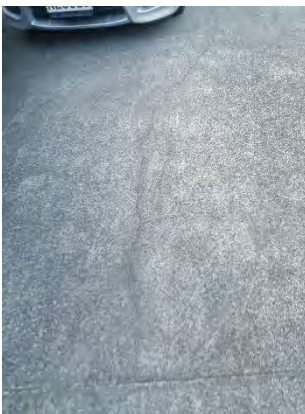
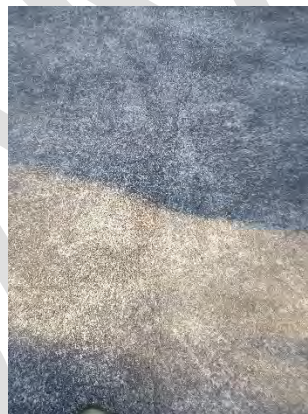
7.4 PATHS AND DRIVEWAYS: ARE ALL AREAS FREE OF SUBSIDENCE/CRACKING, AND ARE THEY UNDAMAGED AND SAFE TO WALK UPON?

Cracks were sighted on the path and driveway from general settlement and movement over the years. Maintenance is recommended to prevent ongoing damage.

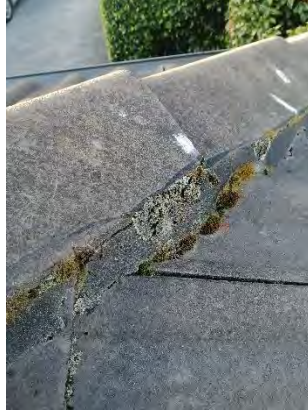
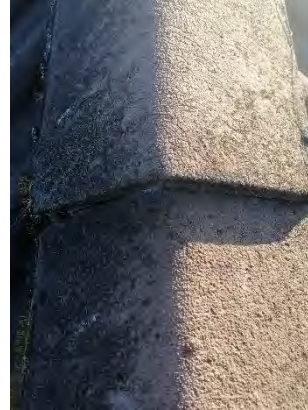
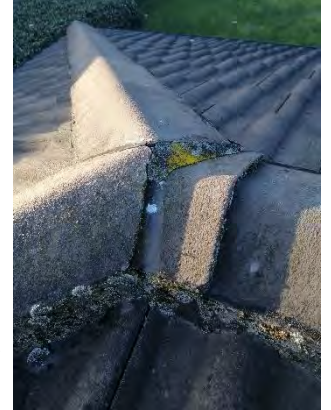
9.2 IS THE ROOF FREE OF CRACKED AND BROKEN/DECAYED ETC?

There were cracks on the pointing and collars, and some collars were missing. Maintenance and repair are recommended to reduce further damage to the roof system.

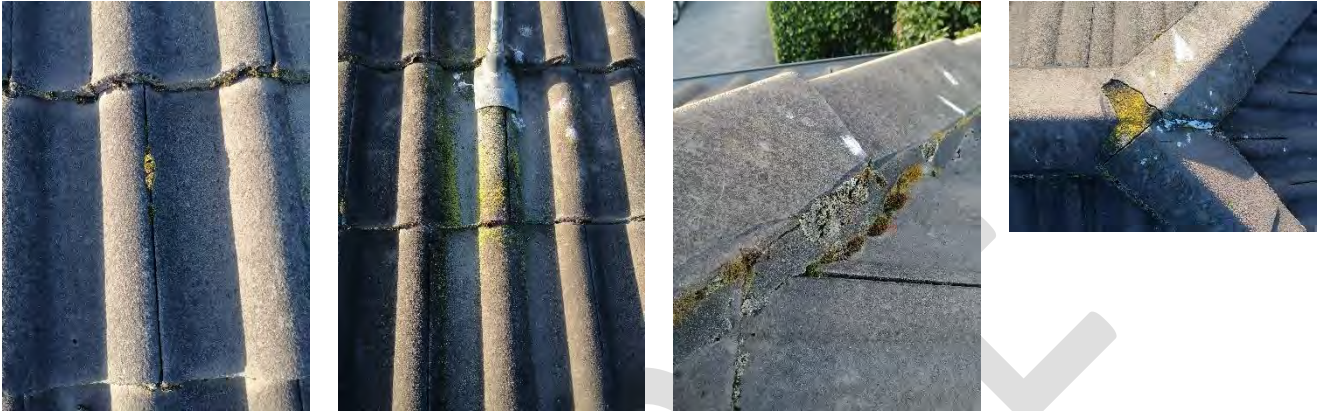
There were lichen and moss on the roof which might cause damage to the roof. Cleaning and regular maintenance are recommended.

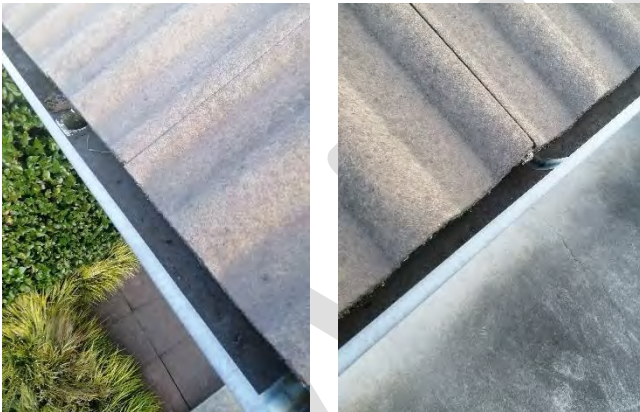
9.5 EAVES, FASCIA, AND SOFFITS

One area of the fascia had corrosion. Maintenance is recommended to reduce further damage.
