Sample Building Inspection Report

Property Address: xxxxxxxx

Inspection Date: 10 January 2024

Prepared By: F Home Inspection

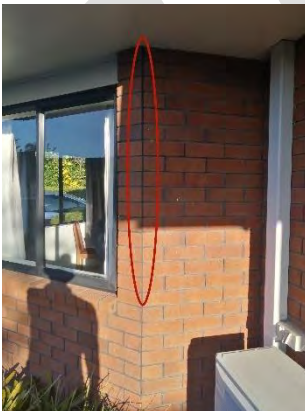
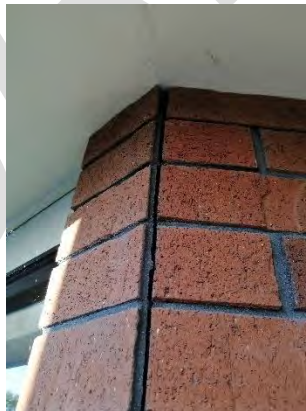
There was a crack in the corner of the wall on the right side of the property. Maintenance and repair are recommended to reduce further damage to the wall cladding system.

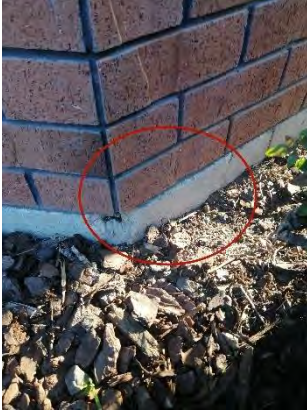
There was a corner crack on the concrete foundation on the right side of the property. Regular monitoring and maintenance are recommended to reduce further damage.

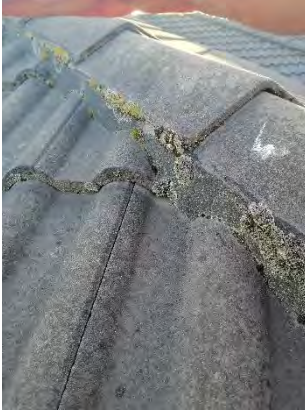
There were cracks on the pointing and collars, and some collars were missing. Maintenance and repair are recommended to reduce further damage to the roof system.

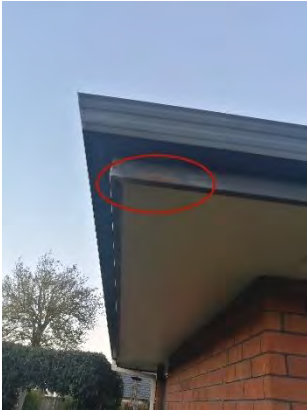
One area of the fascia had corrosion. Maintenance is recommended to reduce further damage.

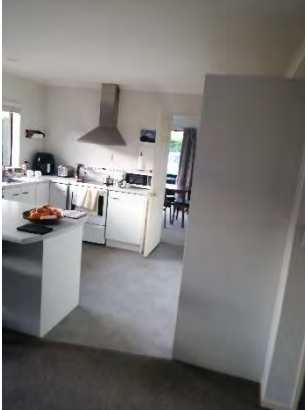
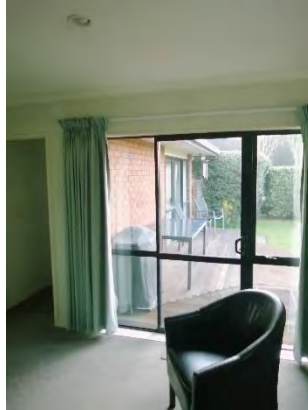
12.6 KITCHEN

Condition: Photo showing overview of the area.

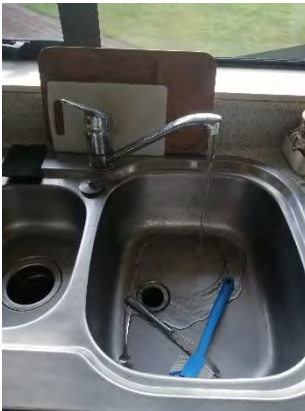
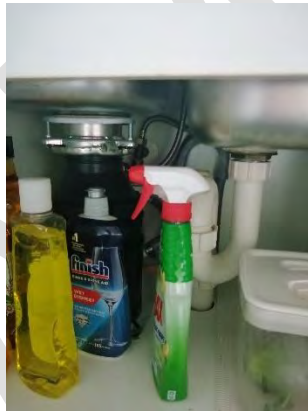
Are the sinks/taps free of defects, leaks and does the water supply operate correctly?
Yes - The sink and taps appeared free from defect and the water supply was operating correctly.

Is the sealing at counter to wall junction in good condition?
Yes.

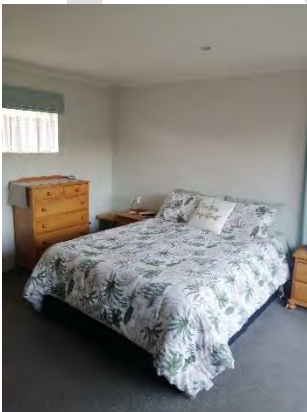
12.7 MASTER BEDROOM

Condition: Photo showing overview of the area.

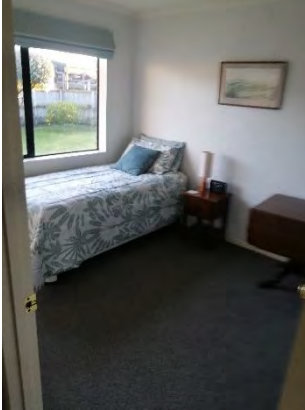
12.8 BEDROOM 2

Condition: Photo showing overview of the area.

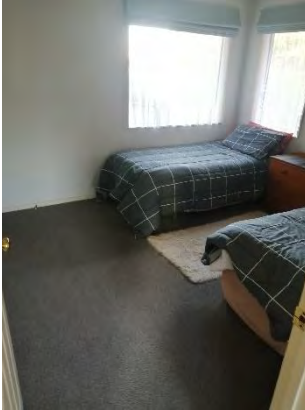
12.9 BEDROOM 3

Condition: Photo showing overview of the area.

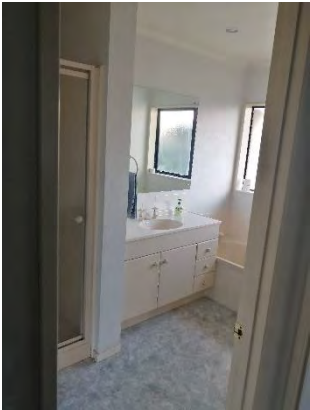
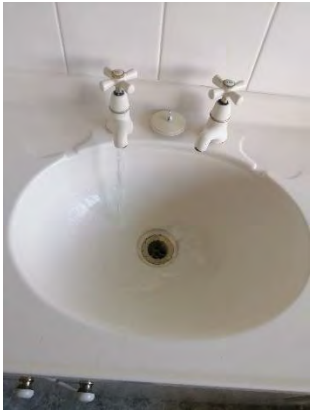
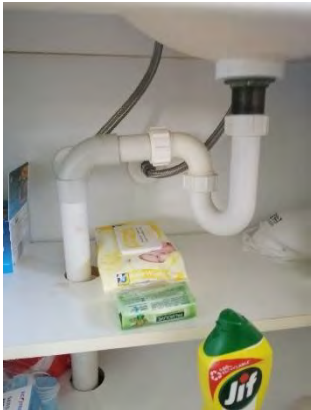
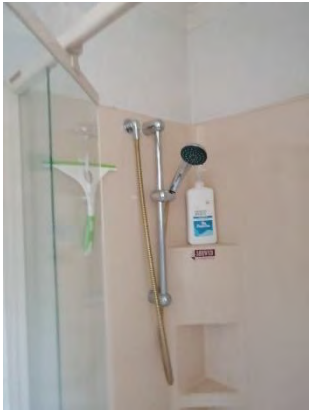
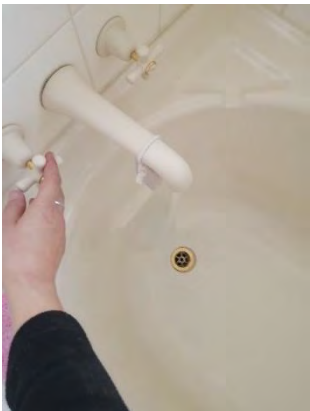
12.11 BATHROOM/WC

Bathroom Condition: Photo showing overview of the area.

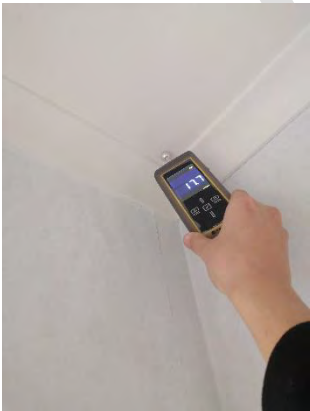
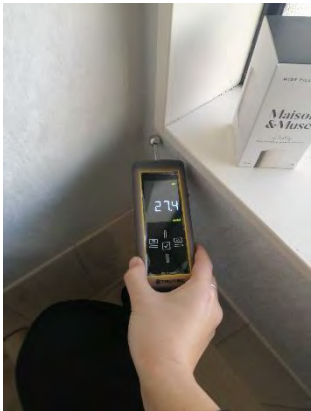
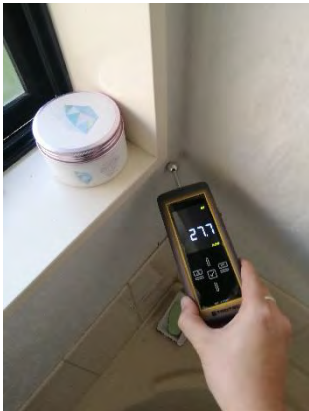
Moisture Readings: Low moisture readings were recorded indicating dry conditions.

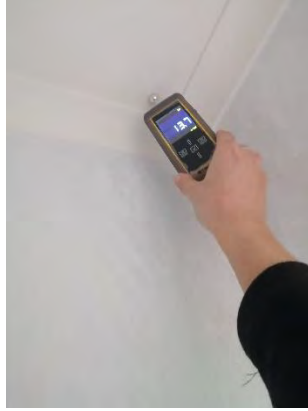
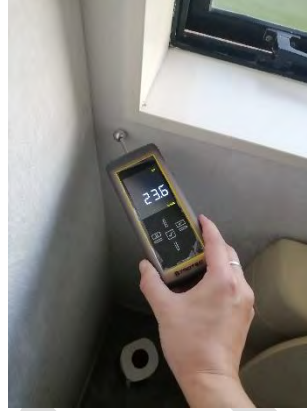
Moisture Readings: Low moisture readings were recorded indicating dry conditions.

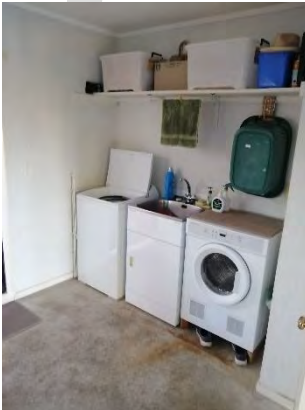
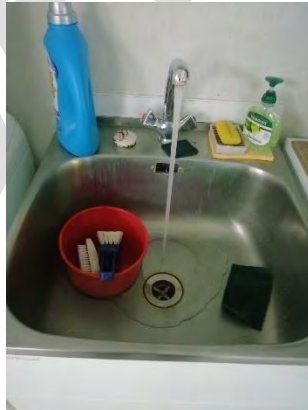
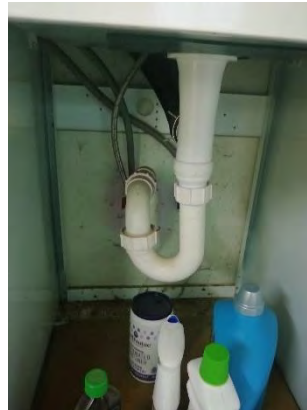
12.12 LAUNDRY

Condition: Photo showing overview of the area.

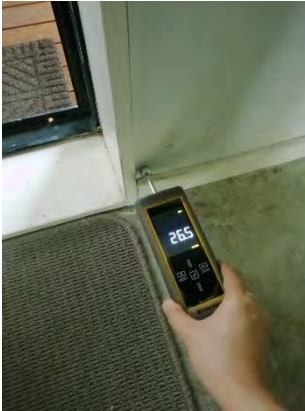
Moisture Readings: Low moisture readings were recorded indicating dry conditions.

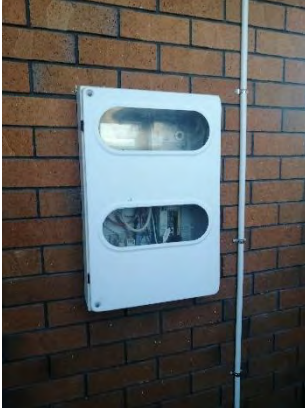
14.3 METER BOARD POSITION

Position: Back of house, Smart meter

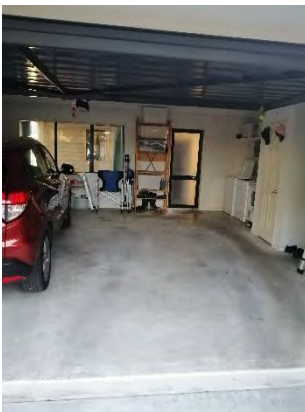
15.2 GENERAL CONDITIONS

Condition: Photo showing overview of the area.

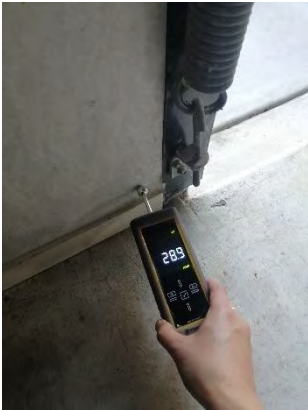
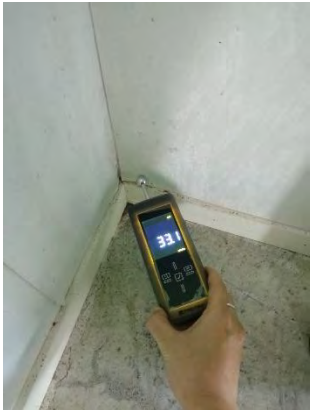
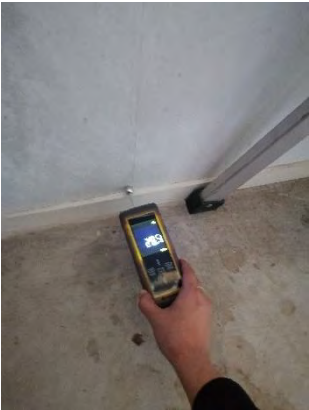
Moisture Readings: Low moisture readings were recorded indicating dry conditions.
